POST-PLANTING INSPECTION
RECORD FOR WOODLAND COMPENSATION

Inspection Date	26 June 2023	Time	0830 - 1100	Inspected By	Project Proponent's Rep.: Toby Li ET Rep: Ana Ng IEC Rep.: Mike Pang Contractor's Rep.: -
Site Location	Ocean Park Water World

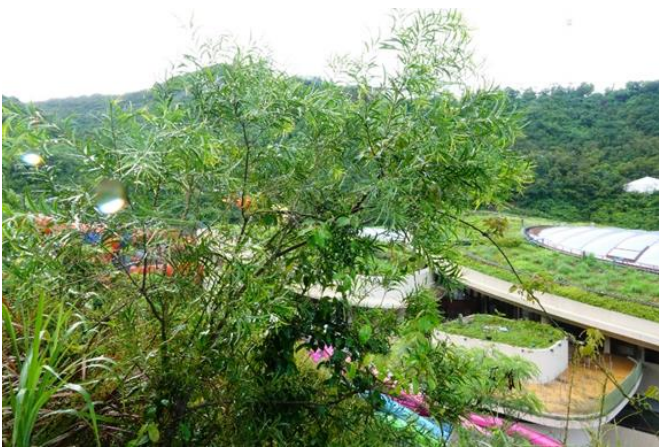
Photo 1 – Representative photo of the proposed planting species, *Acacia confusa*

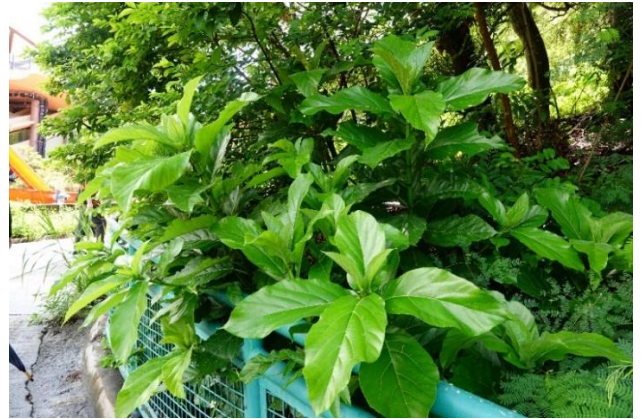
Photo 2 – Representative photo of the proposed planting species, *Ficus hispida*.

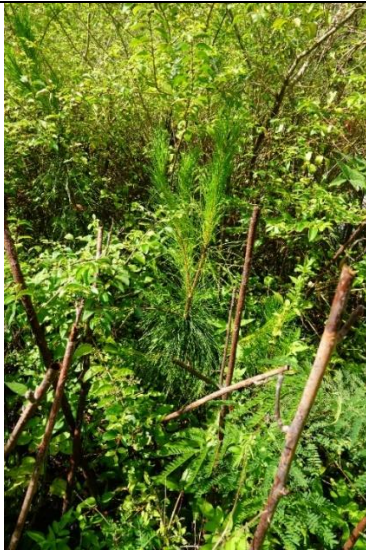
Photo 3 – Representative photo of the proposed planting, *Pinus massoniana*.

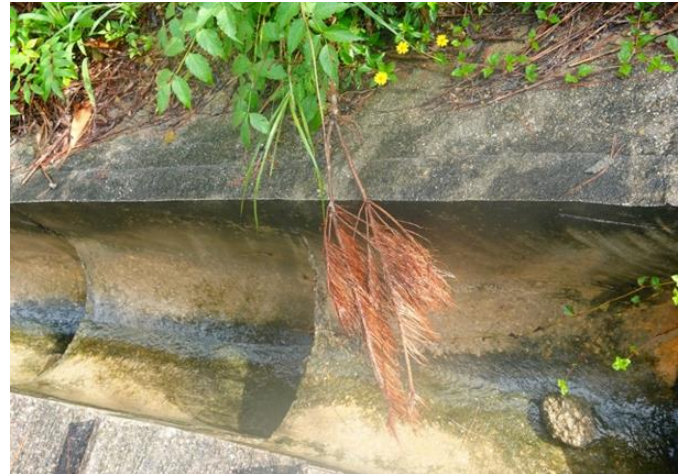
Photo 4 – Representative photo of the proposed planting, *Pinus massoniana* observed to be dead.

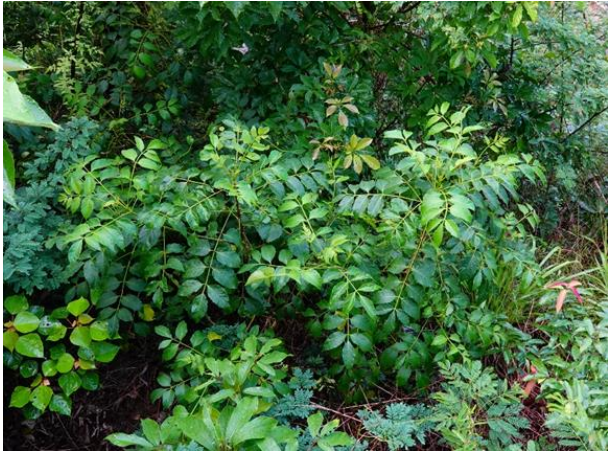
Photo 5 – Representative photo of the proposed planting species, *Brucea javanica*.

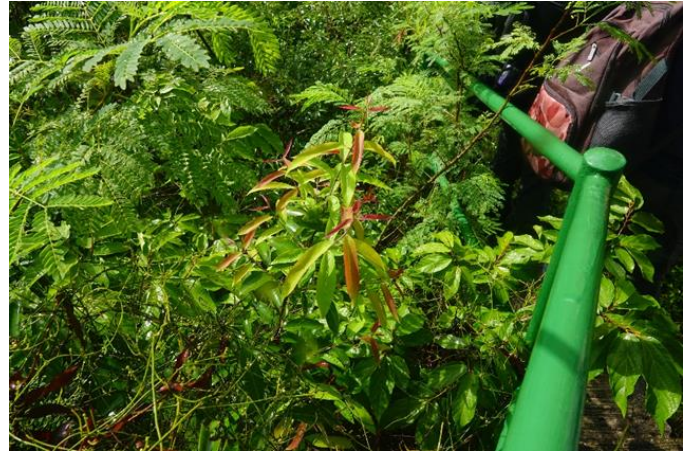
Photo 6 – Representative photo of the proposed planting species, *Cratoxylum cochinchinense*.

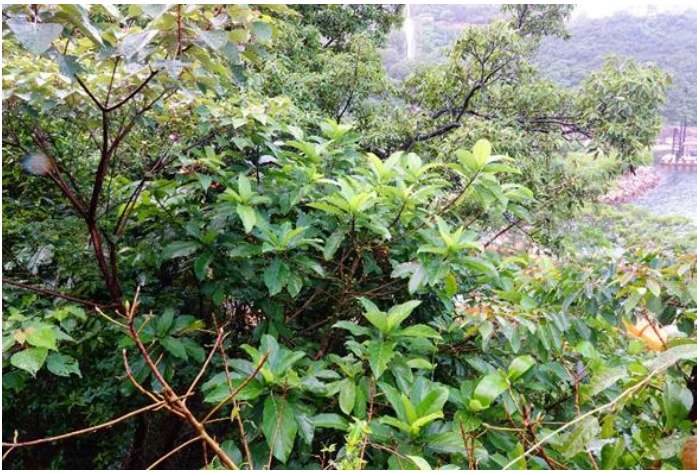
Photo 7 – Representative photo of the proposed planting species, *Ficus variegata*.

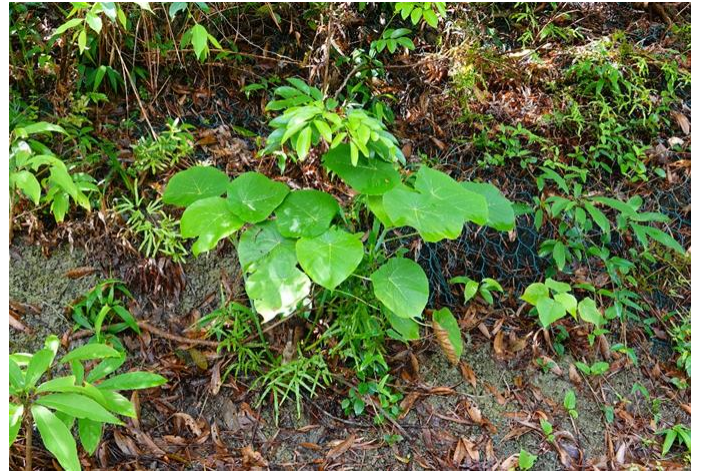
Photo 8 – Representative photo of the proposed planting species, *Macaranga tanarius* var. *tomentosa*.

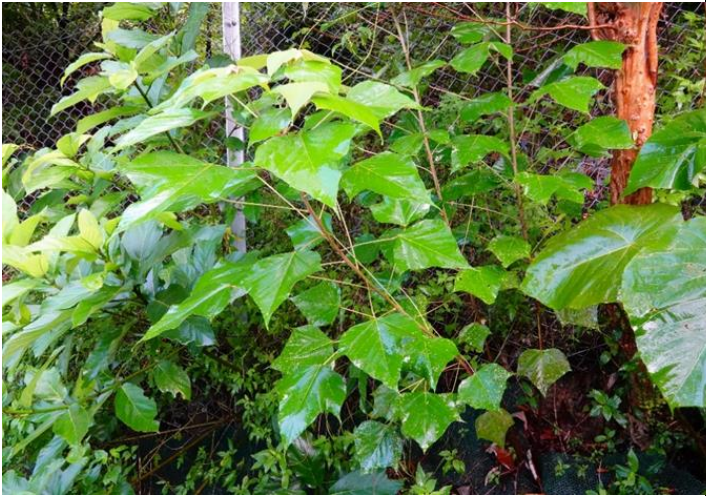
Photo 9 – Representative photo of the proposed planting species, *Mallotus paniculatus*.

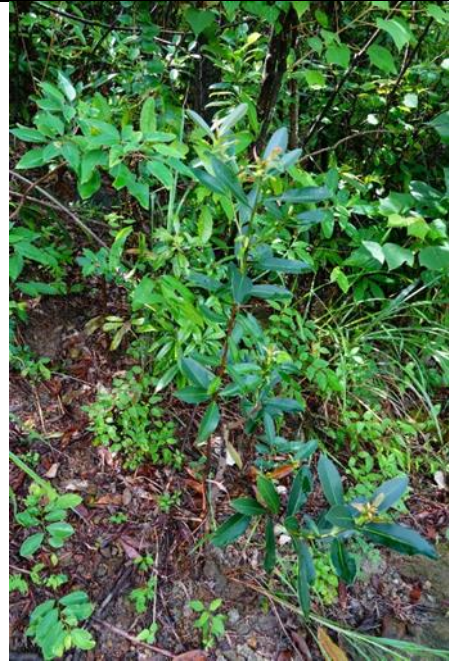
Photo 10 – Representative photo of the proposed planting species, *Choerospondias axillaris*.

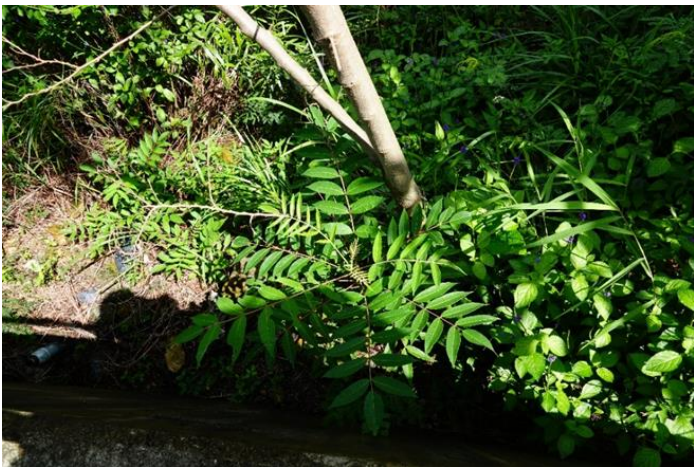
Photo 11 – Representative photo of the proposed planting species, *Rhus succedanea*.

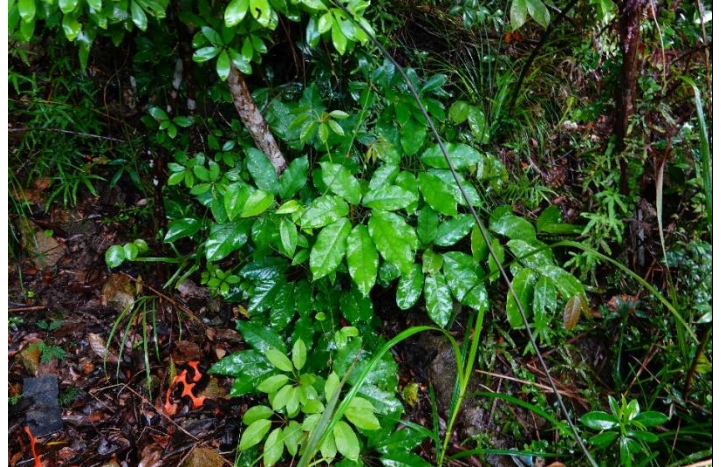
Photo 12 – Representative photo of the proposed planting species, *Schefflera heptaphylla*.

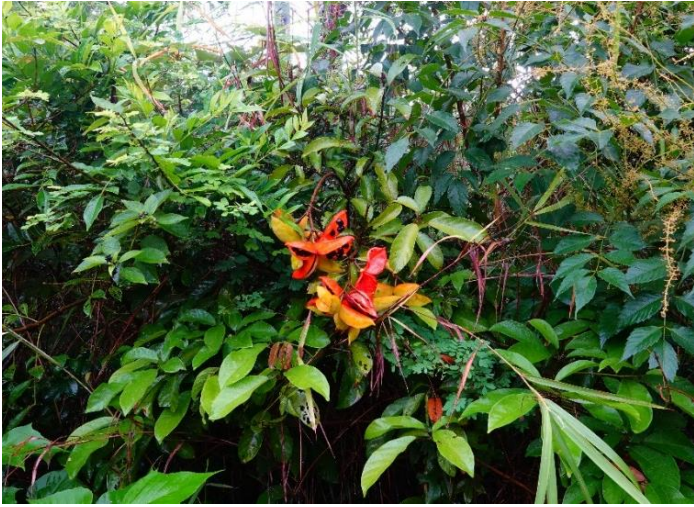
Photo 13 – Representative photo of the proposed planting species, *Sterculia lanceolata*.

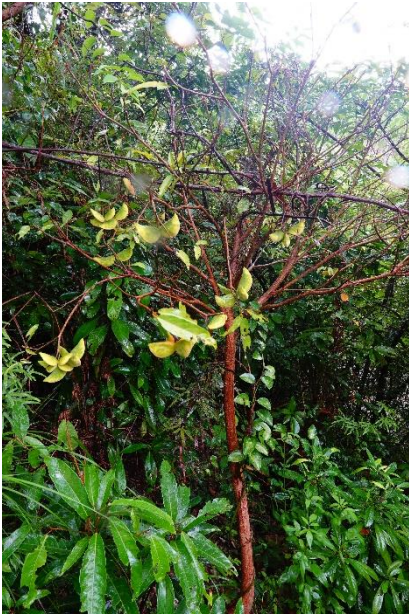
Photo 14 – Representative photo of the proposed planting species, *Sterculia lanceolata* in poor health condition.

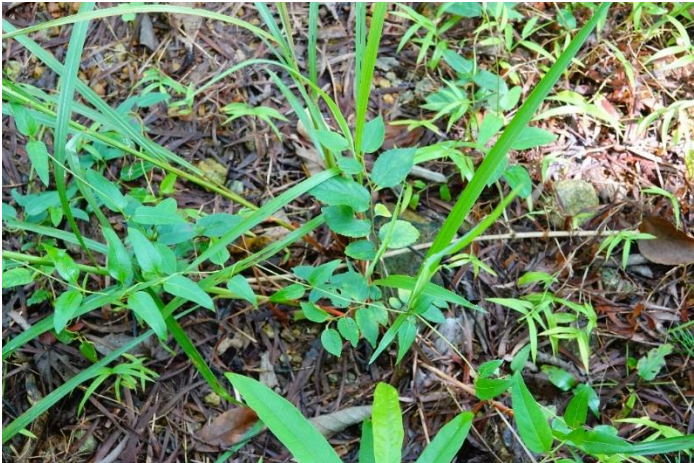
Photo 15 – Representative photo of the proposed planting species, *Celtis sinensis*.

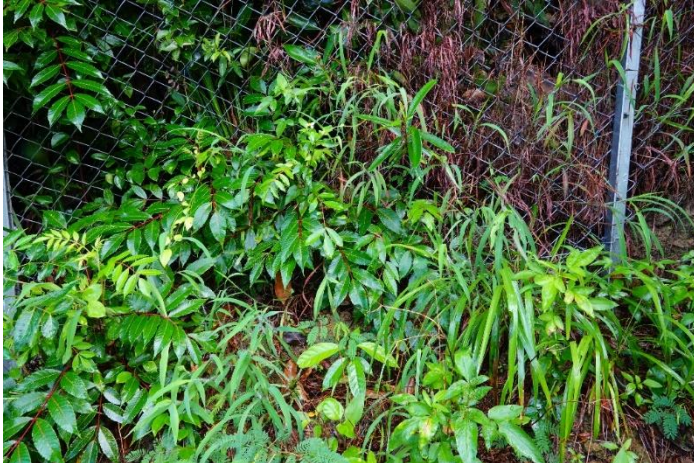
Photo 16 – Representative photo of the proposed planting species, *Choerospondias axillaris*.
