Ocean Park Tai Shue Wan Water World Project

Monthly EM&A Report August 2018

September 2018

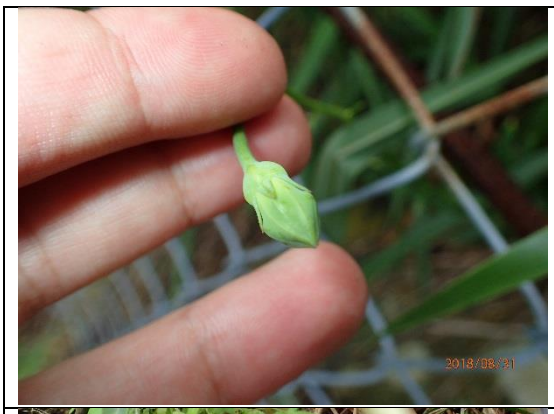
Platycodon grandiflorus is a perennial herb up to 120 cm tall. Stems erect with scarcely any branches. It is often found on sunny grassy hillslopes in brushes. Two groups of *Platycodon grandiflorus* (see Figure 1 of **Appendix L** for their locations) that were recorded in 2015's growing season within the fenced area (see Photos 1 and 2 of **Appendix L** of this report).

On the other hand, the preventive mitigation measures, i.e., erecting of temporary protective fencing and sign post, were found to be effectively implemented for human disturbance (see Photo 3 of **Appendix L** of this report), and there are no signs or evidence (e.g. dust coating of plant) to prove that the on-going construction activities within the Project Area has affected the health condition of the *Platycodon grandiflorus*.

Photo 1 – Group 1 of *Platycodon Grandiforus*
	Photo 2 – Group 2 of *Platycodon Grandiforus*
	Photo 3 – Current situation of fencing and warning sign
